Investigating Mesh Erosion in Pelvic Floor Repair

Report

22 June 2011

FPM-11-0024-R_D

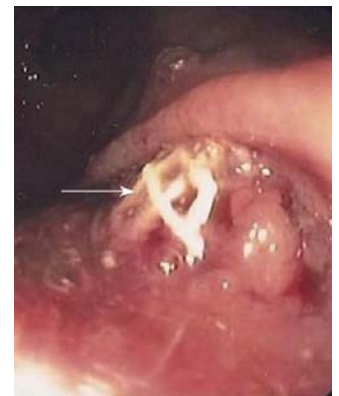
Mesh erosion can cause exposure of the mesh

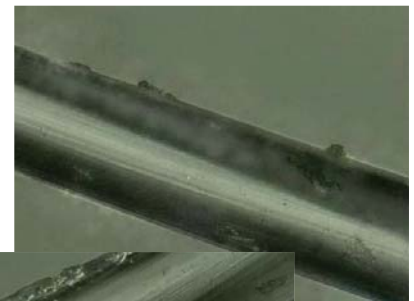
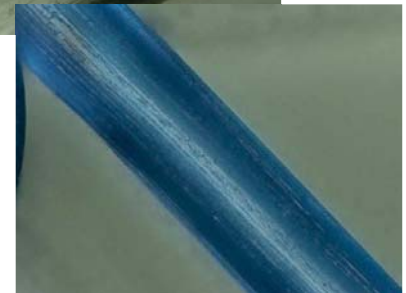
Pictures taken
using Keyence
optical vision
system

- High magnification pictures of filaments within a random sample of finished products show a number of surface effects (note also images on the following slides)

- It is not certain where in the production process these artefacts are generated; perhaps extrusion/winding and scouring
 - We cannot discount the possibility that this type of artefact contributes to the potential for undesirable clinical outcomes

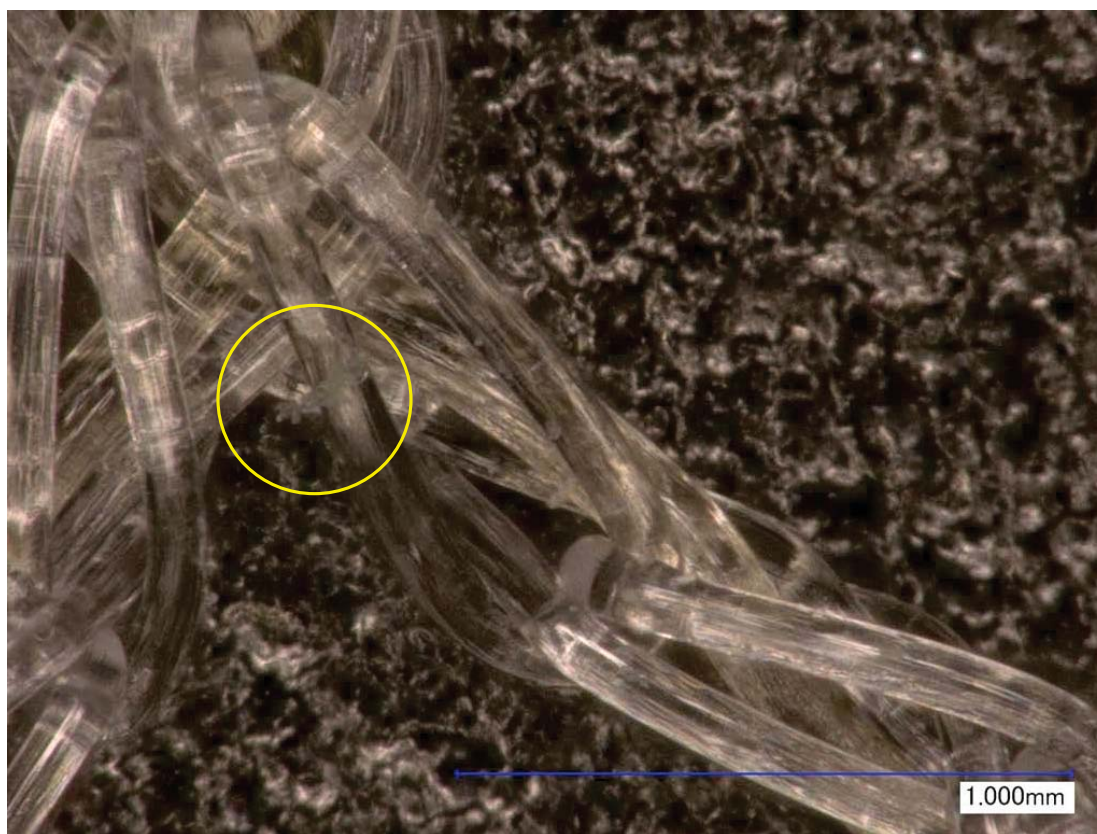
Prolift +M filaments exhibit artefacts on the surface (continued)

Pictures taken using Keyence optical vision system

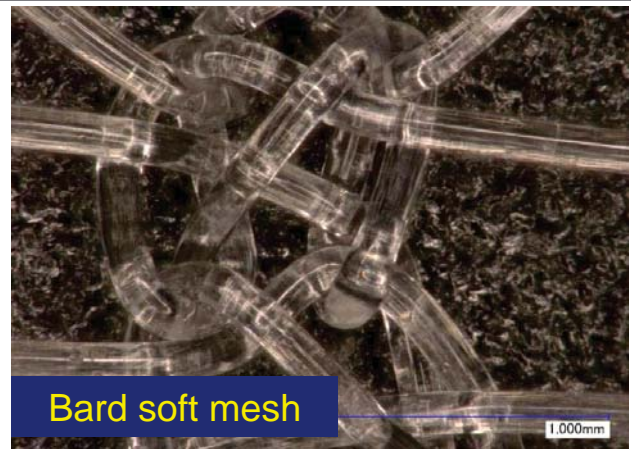
Competitor samples appear not to have the same artefacts – we scanned the filaments extensively
